# **J M Judge & Associates Expert Report**

*3/4/2022*

*Hilltop Church of The  
Nazarene*

10818 University Blvd.

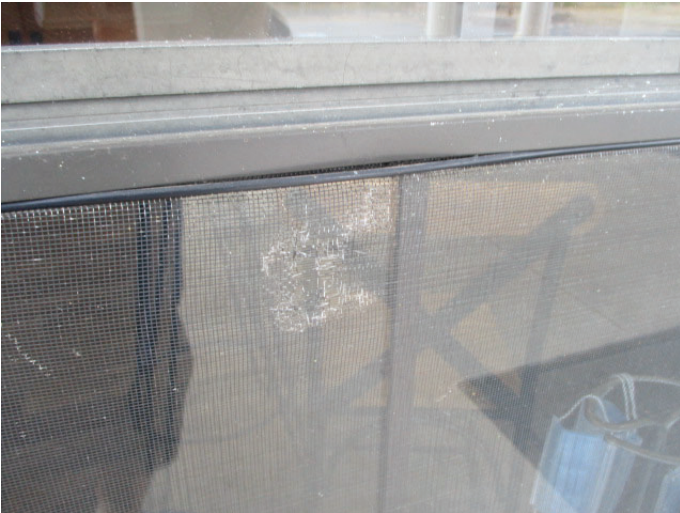
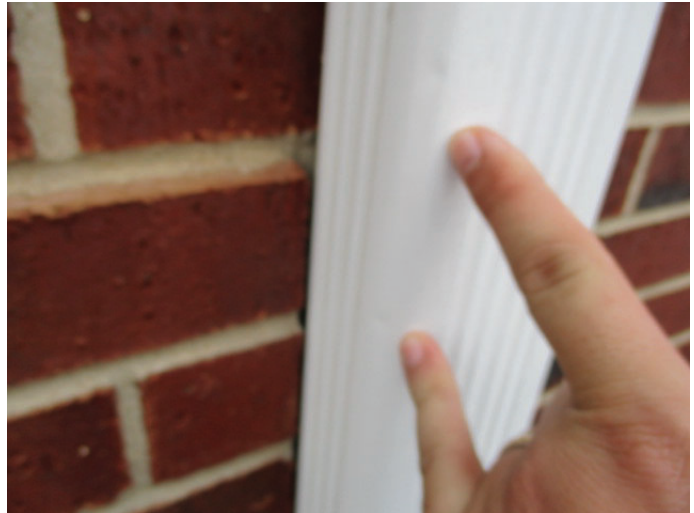
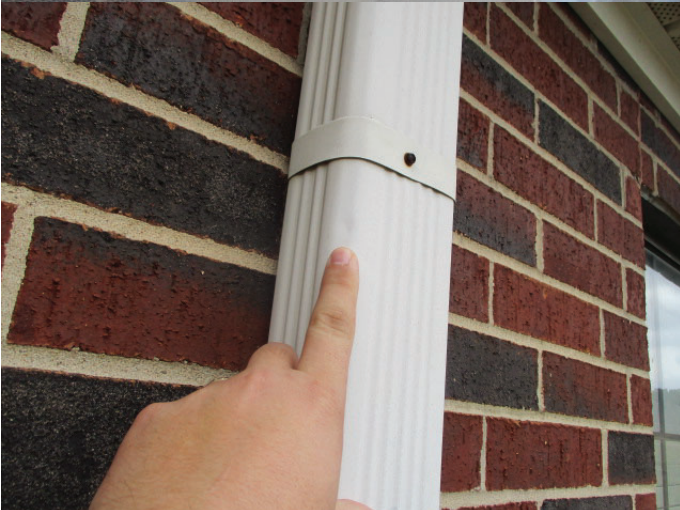
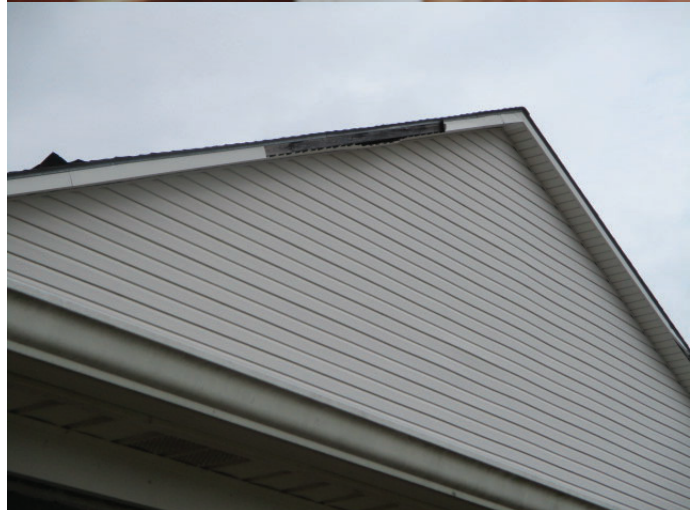
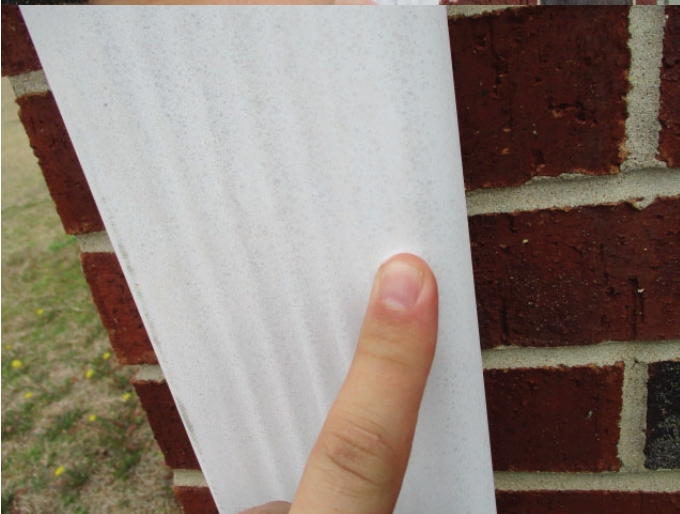
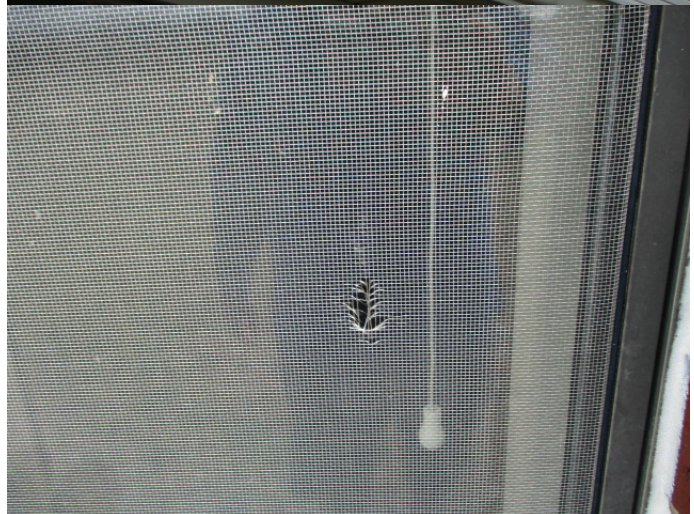
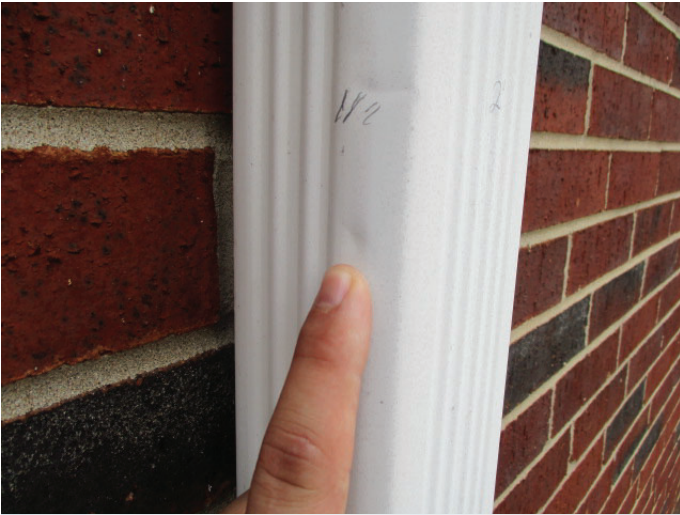
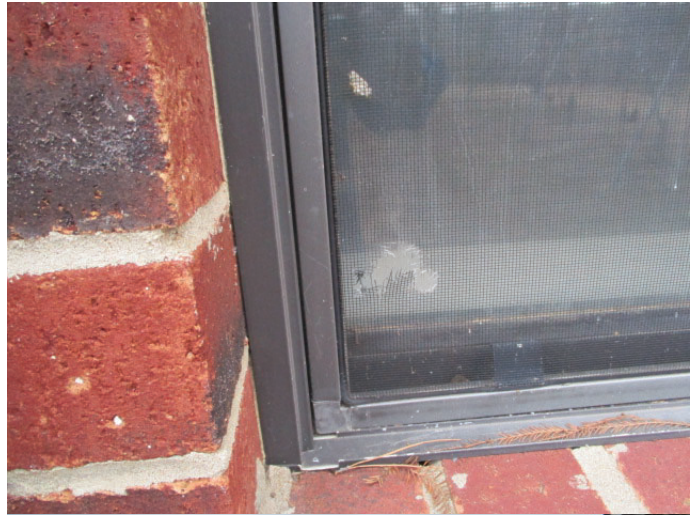
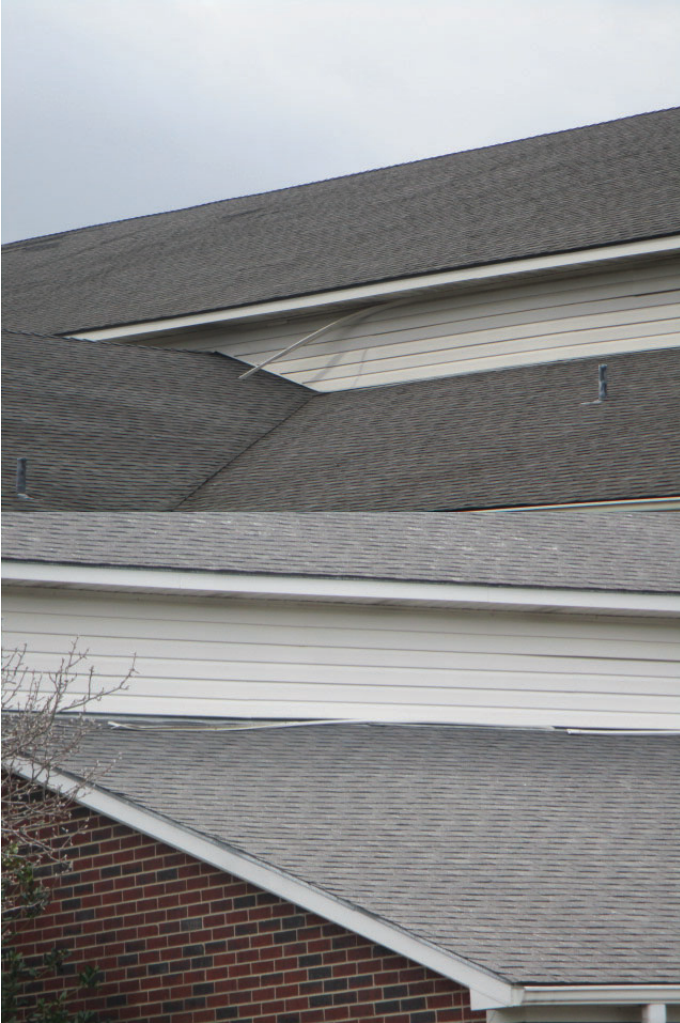
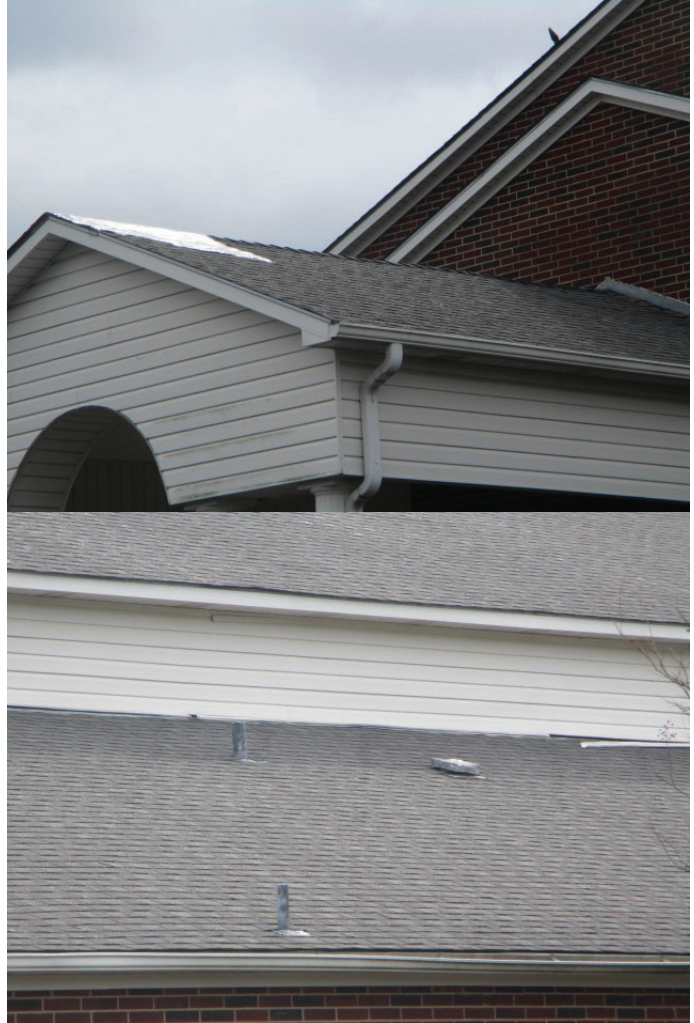
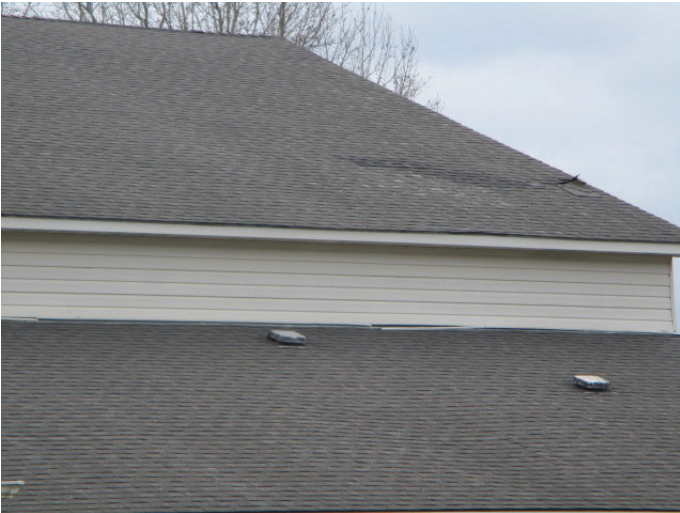
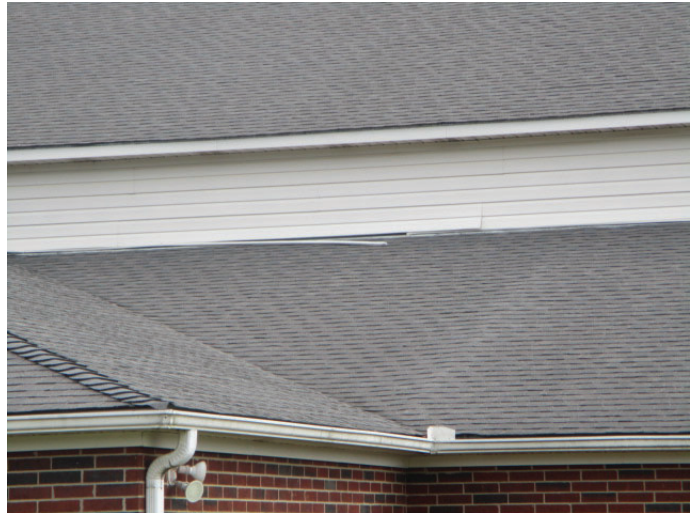
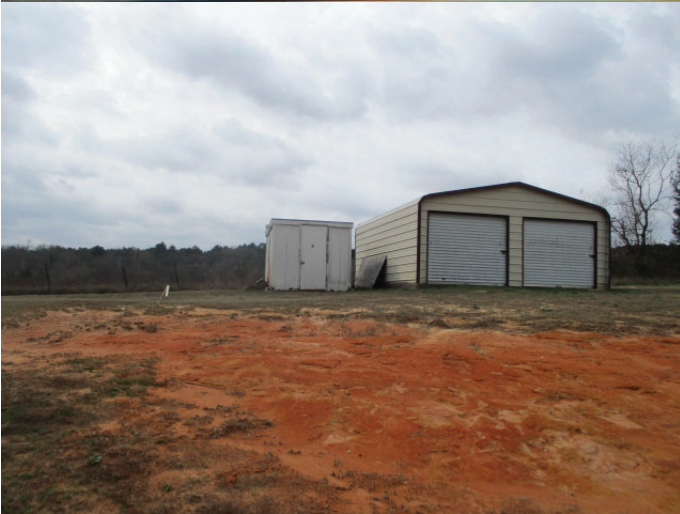
**Wind Evaluation:** There are several temporary repairs, primarily caused by wind associated with the Storm Event. Additionally, there is substantial damage to the Vinyl Siding, fascia and soffit.

**Wind Summary:** Damage, is evidenced by the Temporary repairs to the roof and the loose or missing Vinyl Siding, soffit and fascia.

Impact Damage to Screen

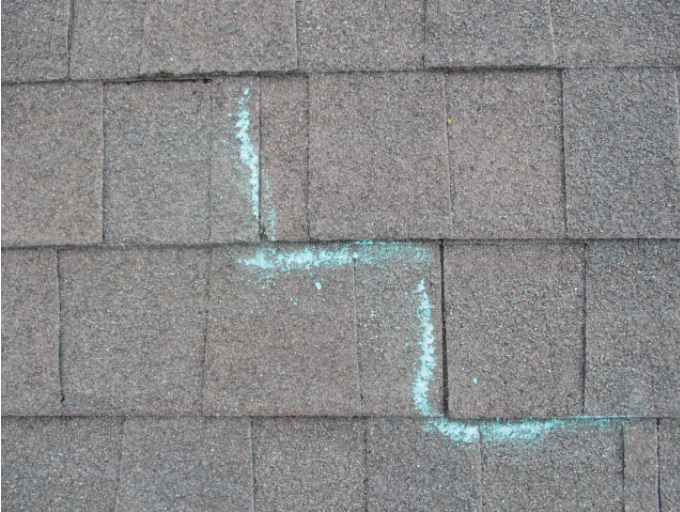
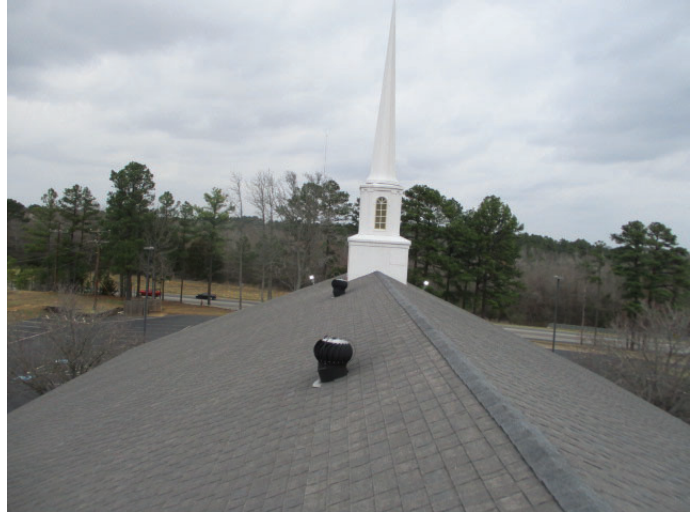
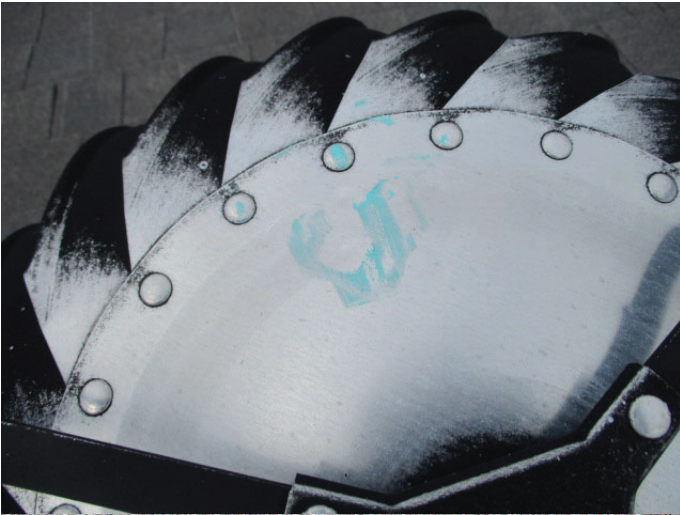
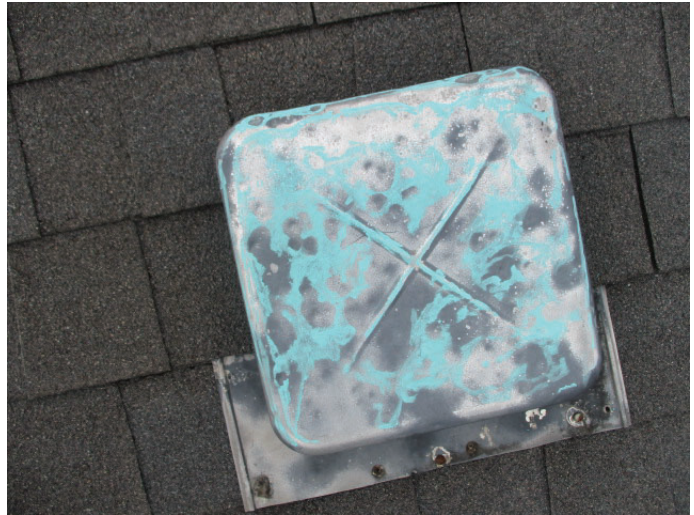
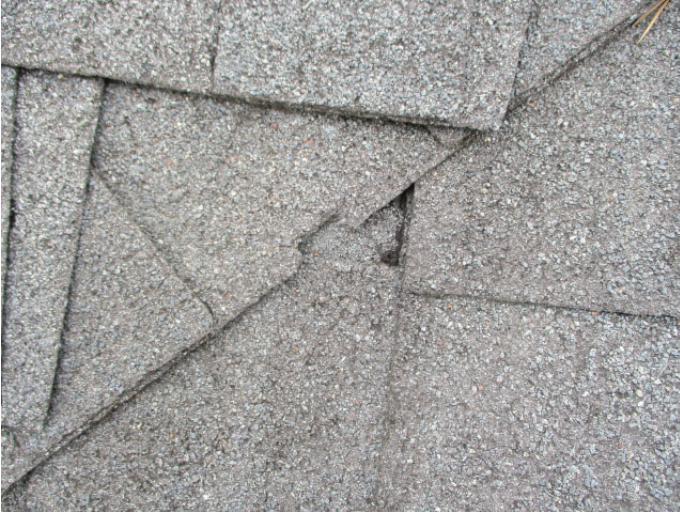
# Sample of Roof Damage

**Hail Evaluation:** Multiple recent hail penetrations consistent with the March 2019 storm event. These penetrations have damaged the Light Weight Laminate Roof system and allowed water to penetrate the roof covering. These storm created openings constitute functional damage and have shorthand life span of the roof covering and associated components.

**Hail Summary:** Hail has struck the entirety of the roof located at the address mentioned above and has damaged it to the point that it needs to be replaced, said damage has caused leaks allowing water marks and destruction to the interior.

1. Impact damage has occurred throughout the Roof Covering.
2. The Asphalt shingles are brittle and show evidence of Scouring, Impact Damage and Wind Damage.
3. Damage is far too numerous to repair.
4. This is a storm damaged roof in need of full replacement.
5. Vinyl Siding, fascia and soffit are also damaged beyond repair and in need of replacement.

Replacement; See estimate attached
